CASE STUDY

Site: Boundary House, Coalville

Job 1: Metal Box Gutter Refurbishment with Giromax® Guttercoat

Job 2: Commercial Roof Refurbishment with Giromax® Roofcoat (Metal)

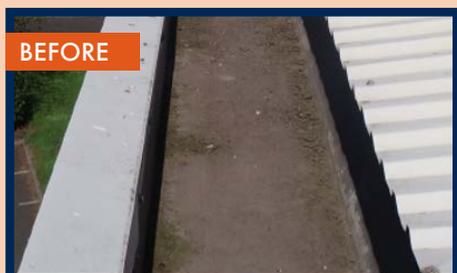
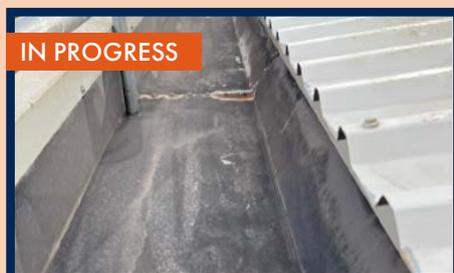
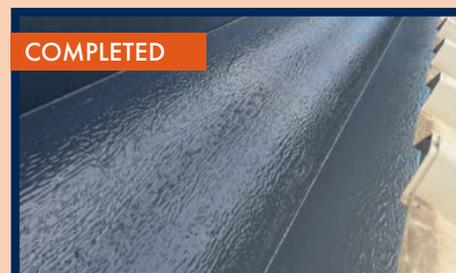
The metal box gutters on the property were cleared of all debris and silt, thoroughly washed and swept through. Following this all loose surface corrosion was removed in preparation for treatment. All substrates were then primed.

Gutter joints were then sealed using Giromax® Edgecoat which left them watertight.

Three hundred and sixty meters (360m) of metal box gutters required treatment to extend their service life. Existing gutters were corroded and leaking at the gutter joints. A full liquid coating treatment - Giromax® Guttercoat was applied to address corrosion and leakage to leave it serviceable for at least 15 years.

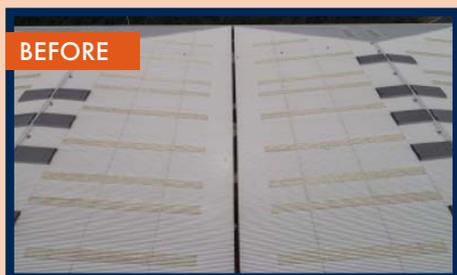
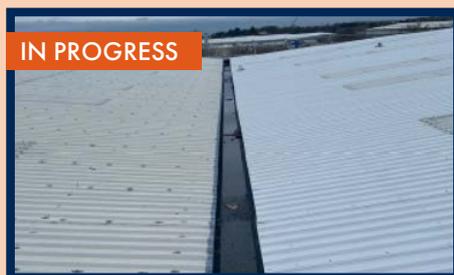
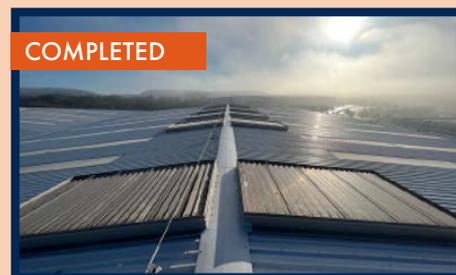
The pitched metal roof surfaces required thorough cleaning at high pressure to remove the build up of dirt films that had accumulated on the roof over many years. Further to this loose coatings were removed with the jet wash to prepare all areas back to a firm edge in preparation for coating.

The existing metal roof was weathered, with fairly advanced cut edge corrosion present. The original factory applied coatings had begun to micro check and degrade. As a result it was decided to treat over 5,500 m² of metal roof with Giromax® Roofcoat (Metal). Following successful application a 20 year guarantee was issued.
